UNDERWATER BRIDGE INSPECTION REPORT

STRUCTURE NO. 58506

SNAKE RIVER

MINNESOTA DEPARTMENT OF TRANSPORTATION
UNDERWATER BRIDGE INSPECTION

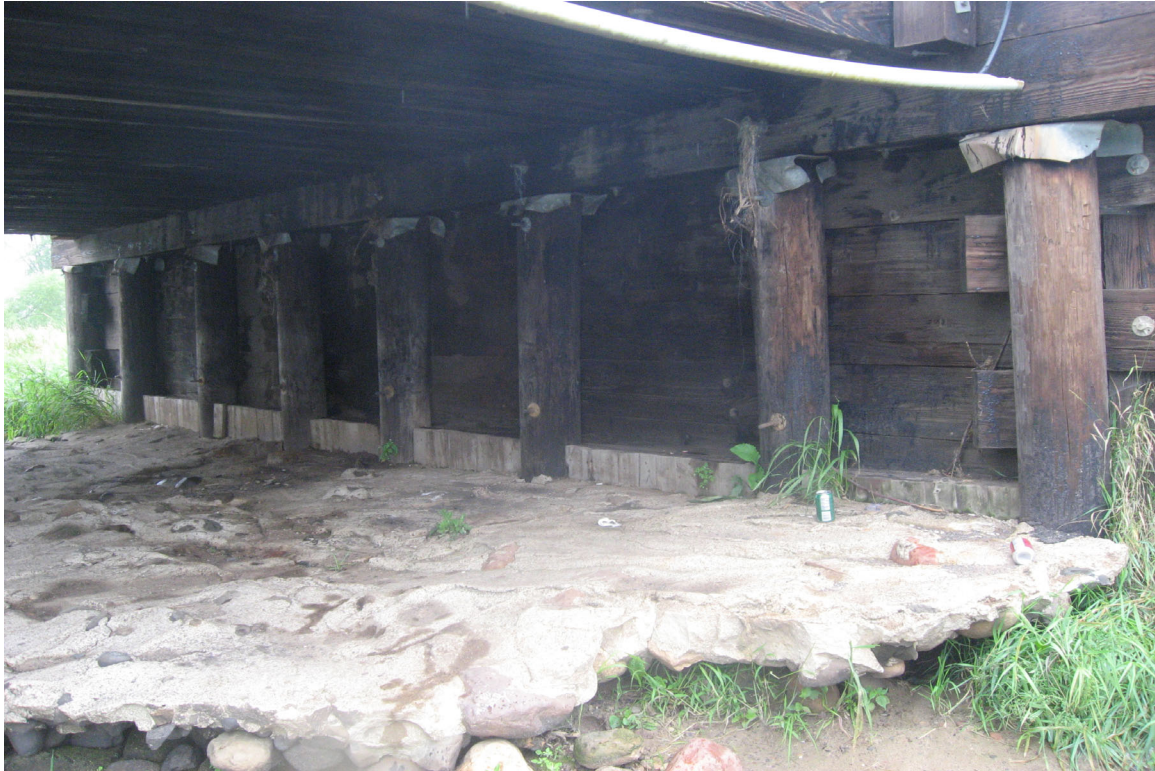
Photograph 1. View of North Abutment, Looking Northwest.

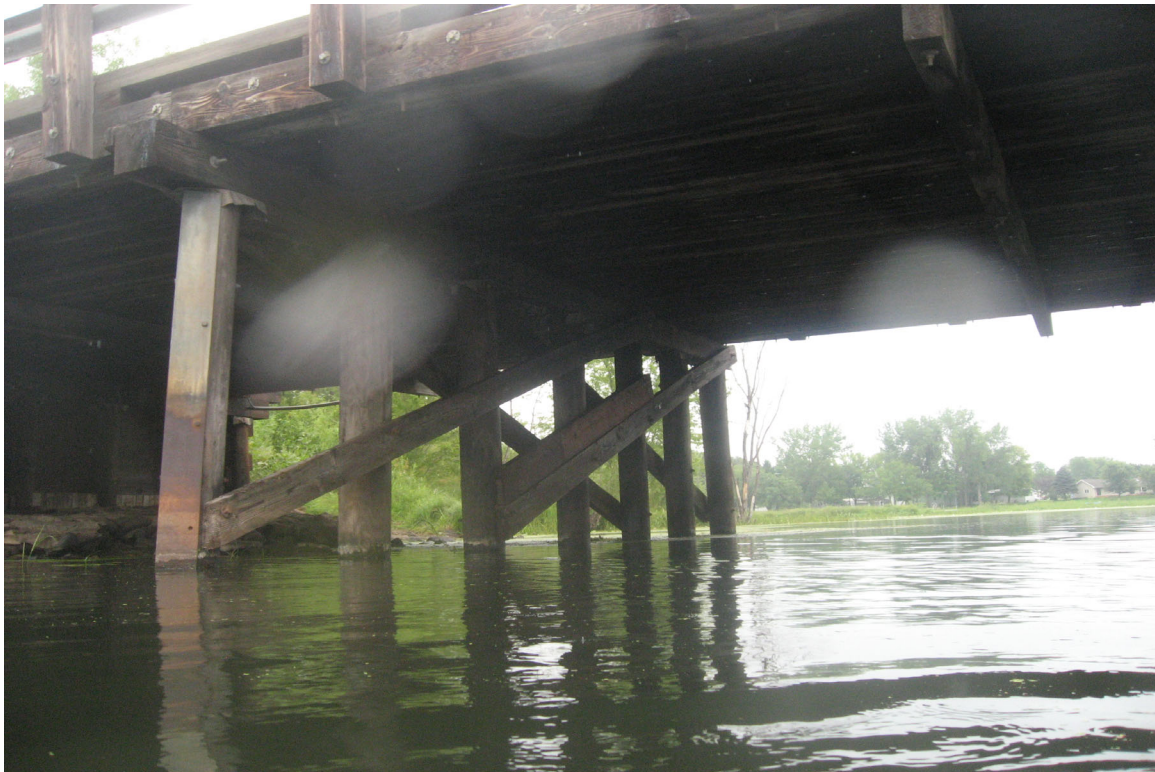
Photograph 2. View of Pier 1, Looking Northeast.

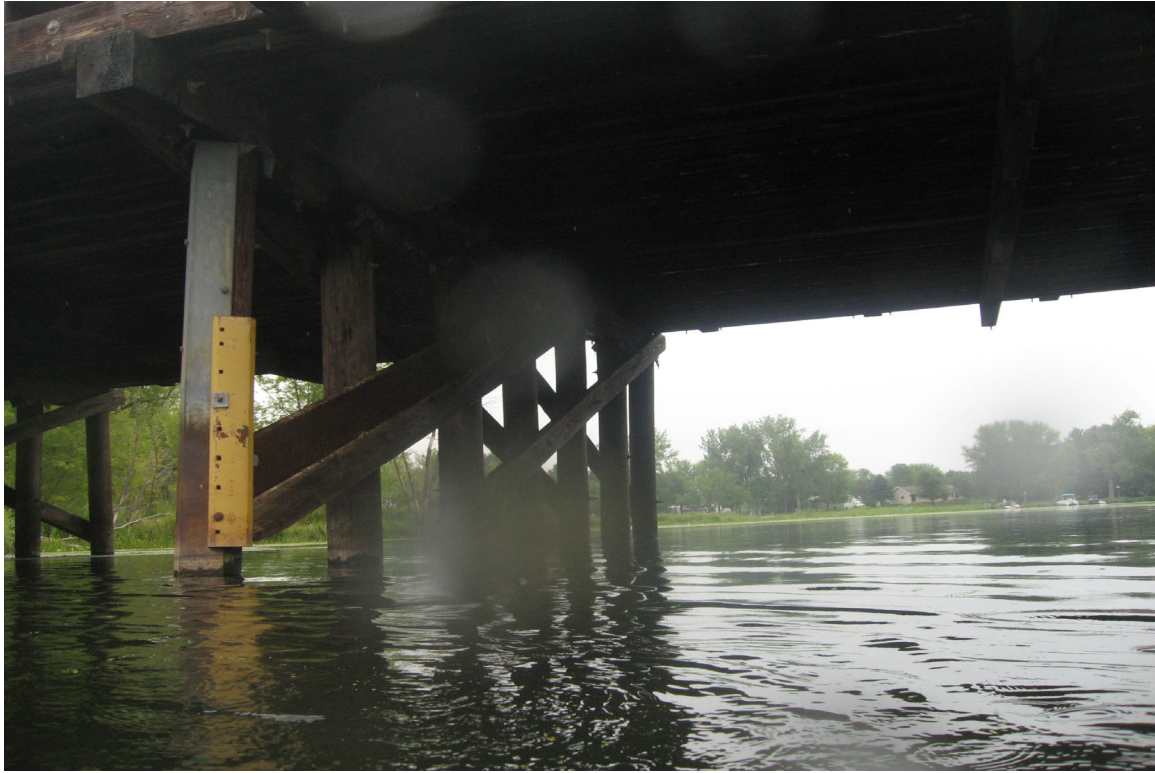
- (D) Light accumulations of timber debris, consisting of 6 inch diameter and smaller limbs and branches, was observed at the upstream noses of Piers 2, 3, 4, and 7.

Photograph 3. View of Pier 2, Looking Northeast.

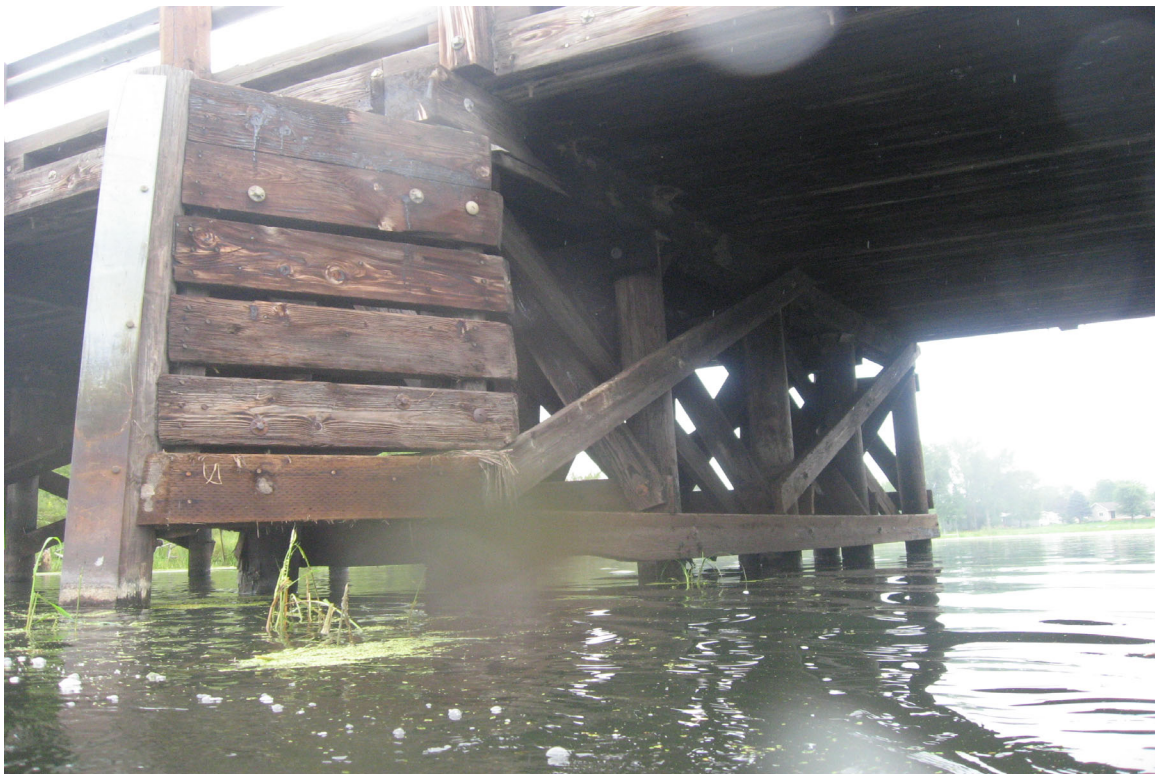
- * The outer 1.5 inch shell of the end pile at west end of Pier 3 was cracked and splintered. This condition was present from 6 inches below the waterline to 1.5 feet above the waterline.

Photograph 4. View of Pier 3, Looking Northeast.

- (A) The cracked, split, and deteriorated pier cross-bracing should be replaced to restore the lateral stability of the piers.

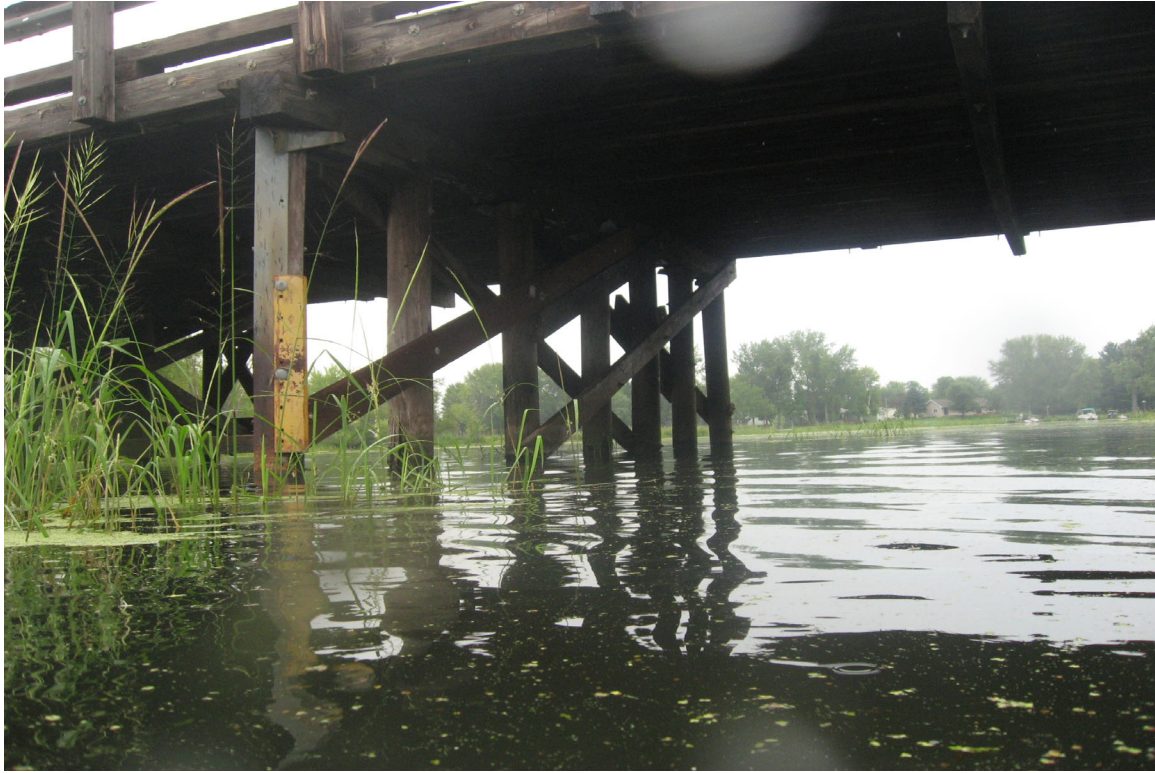
- * The outer 2 inch shell was cracked, splintered, soft, and delaminated at the second pile from the west end of Pier 4.
 - * The westernmost pile on the south side of Pier 7 was splintered over a 12 inch high by 6 inch wide by 3/4 inch deep area. This area was located 2 feet below the waterline. The material beneath the splintered material was soft to an estimated depth of 1/4 inch. The total loss of cross-section at this location was estimated to be between 10 and 20 percent.

Photograph 5. View of Pier 4, Looking Northeast.
